# **TRIAL DREDGING REPORT**

**Anchorage Harbor Deepening**  
**Port of Anchorage, Alaska**

**November 2008**

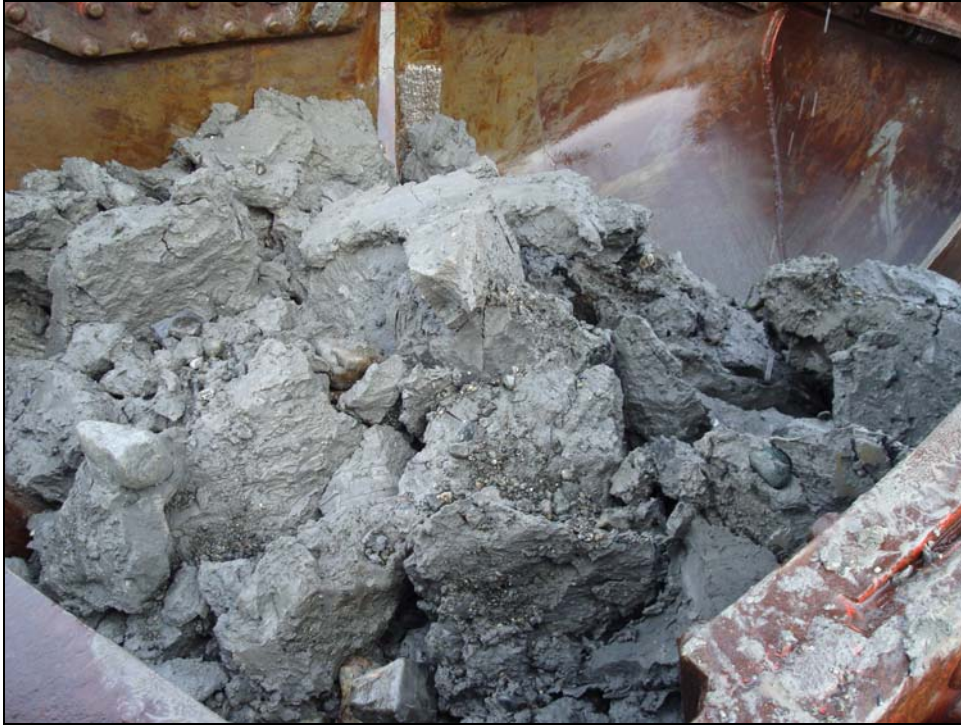
Photograph 25: Clayey gravel with sand and cobbles (GC) dredged at trial dredge area 3 (AP-4590).

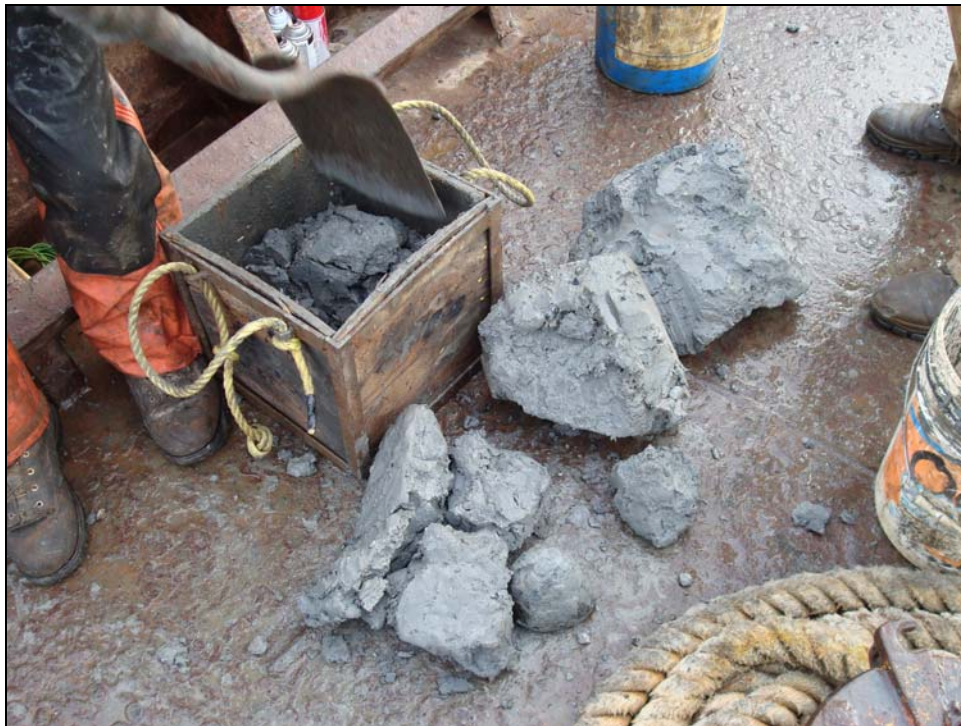
Photograph 26: Clayey gravel with sand (GC) (131.0 pounds per cubic foot) dredged at trial dredge area 3 (AP-4590).

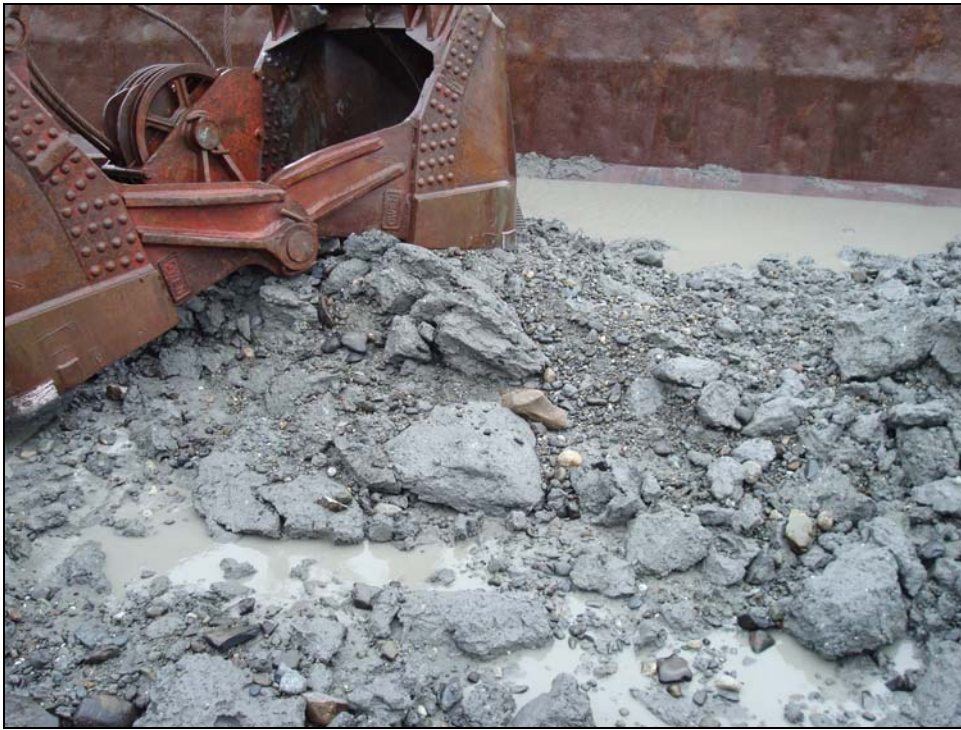
Photograph 27: Clayey gravel with sand and cobbles (GC) dredged at trial dredge area 3 (AP-4590).
